**State of Louisiana
Department of Natural Resources
Coastal Engineering Division**

**2005/2006 Annual Inspection
Report**

**LAKE PORTAGE LAND
BRIDGE PROJECT
(TV-17)**

October 20, 2005
Vermilion Parish

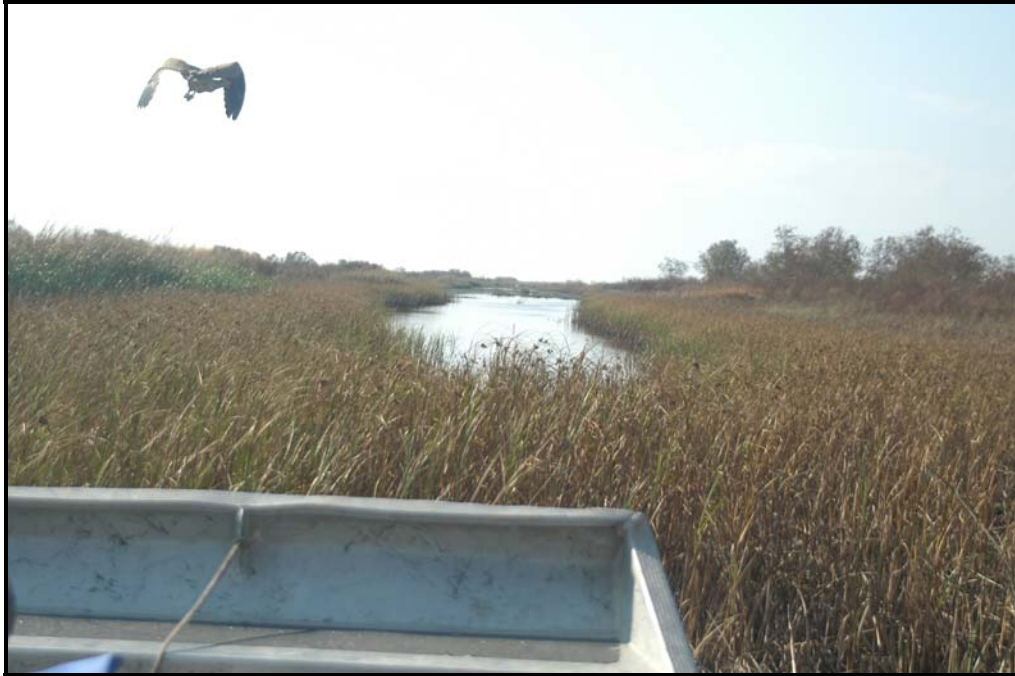
Area 1 is in good condition and vegetation has continued to expand from the containment banks moving towards the center of the channel. Recent aerial photographs taken by LDWF show increased vegetation growth which should continue with warmer temperatures into the future. In some areas the entire channel width was vegetated. The center part of the filled in channel was wet, passable only by airboat, and is still draining storm surge water from Hurricane Rita. Salinity was measured at 14 ppt in the channel area. As a result of the

inspection of Area 1, LDNR and NRCS agree that no corrective actions will be required this year. (Photos: Appendix B, Photo 1).

Photo 1, Area 1, Post Hurricane Rita. Note vegetation has completely filled in the plug area in some places.

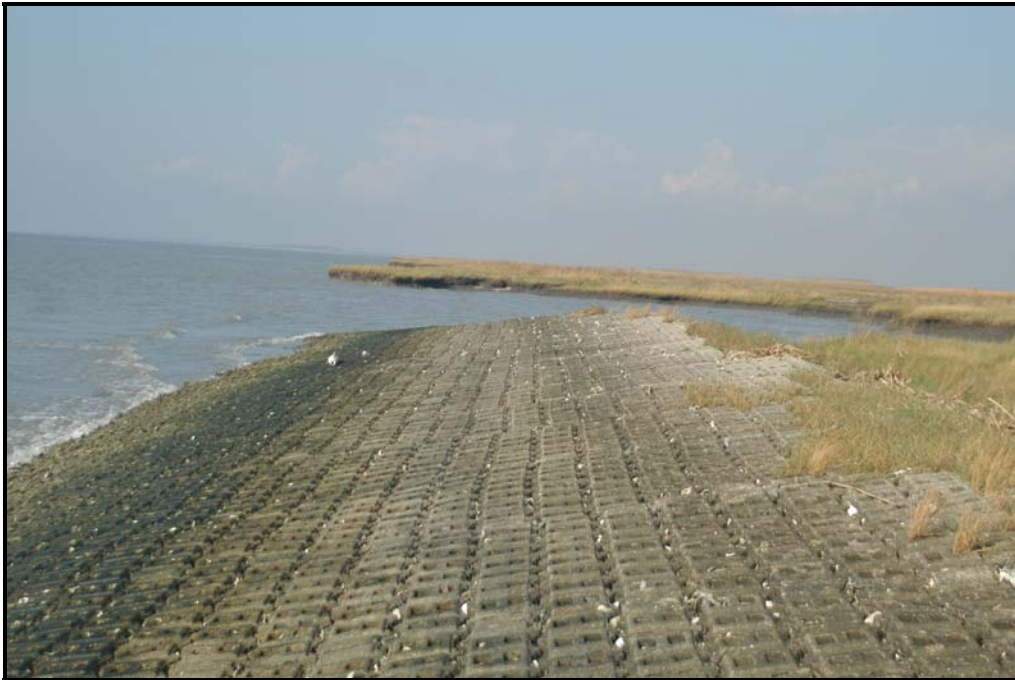
Area 2 is also in good condition and is fully vegetated, such that this reach was preexisting with additional dredge material added through this project to fill in any trevasses. Some erosion along the ends of the concrete mats along the Gulf shoreline has occurred due to Hurricane Rita. Salinity was measured at 16.5 ppt in the Gulf waters. LDNR and NRCS agree that no maintenance will be required at this time; however this area needs to be monitored closely on future annual inspections. (Photos: Appendix B, Photos 2, 3, 4, & 5).

Photo 2, Area 2, Post Hurricane Rita, West side of concrete mats.

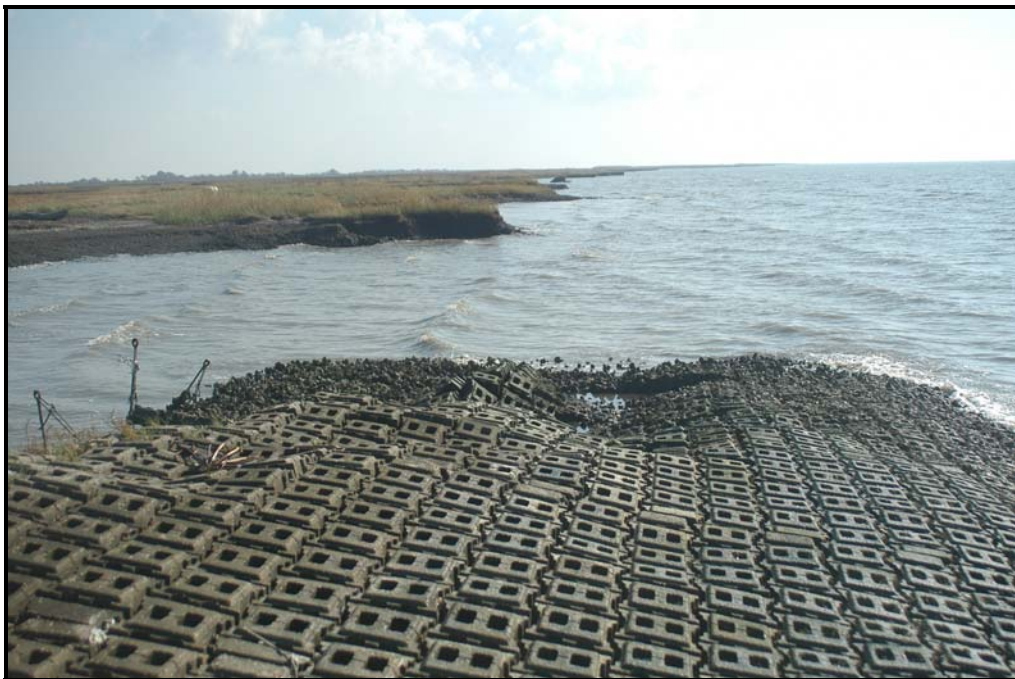
Photo 4, Area 2, Post Hurricane Rita, East side of concrete mats.
